6 Build Reports and Analysis

6.1 Overview of the DBDOC build reports

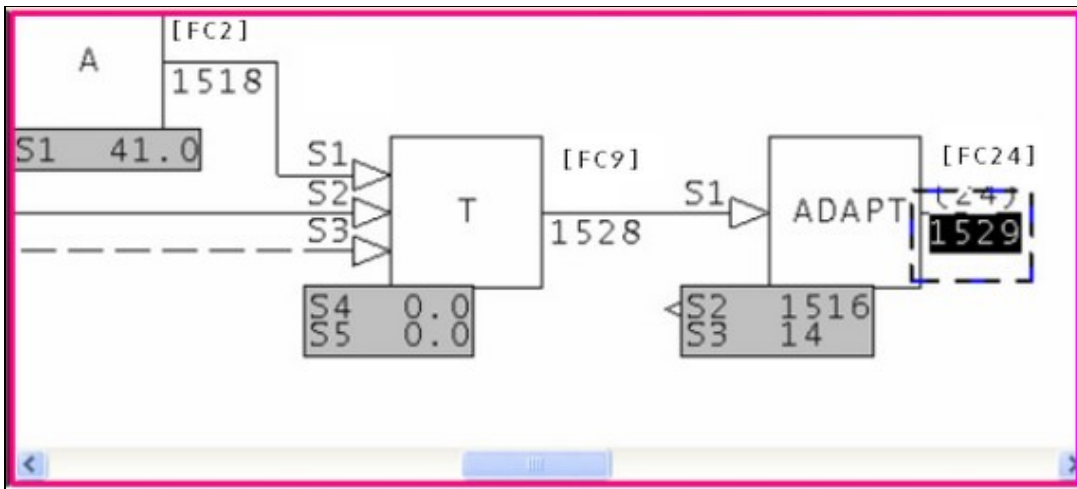
```
Adapt block Module 4,50,02 Block 1529 on drawing 45002P3:  
Spec 14 on block 1516 out of range, (function code 40).
```

Click on the link in the error browser to bring up the CLD/CAD sheet where we have an adapt block issue.

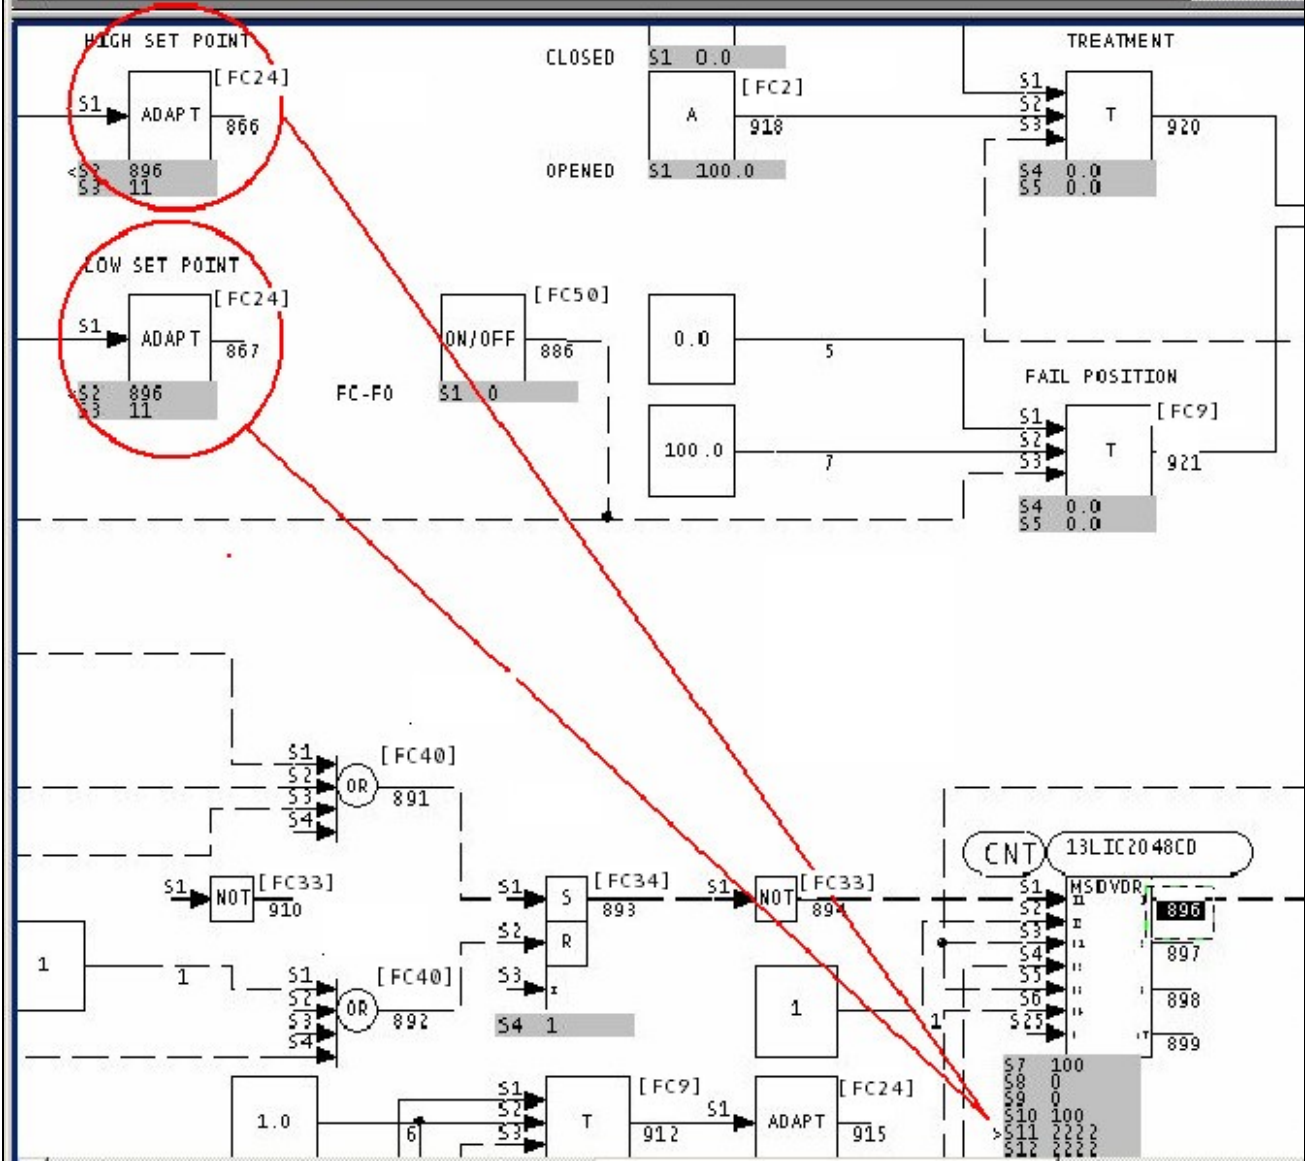
This drawing shows more than one, except that it is likely this is actually abandoned logic. Sheet Z9, as the last sheet, is often a boneyard sheet. Here, legal blocks have probably been used badly.

- 2. 28002Z9C.CAD S11 adapted by block 866
- 3. 28002Z9C.CAD Source (FC 129 MULTI-STATE DEVICE DRIVER)
- 4. 28002Z9C.CAD S14 adapted by block 932

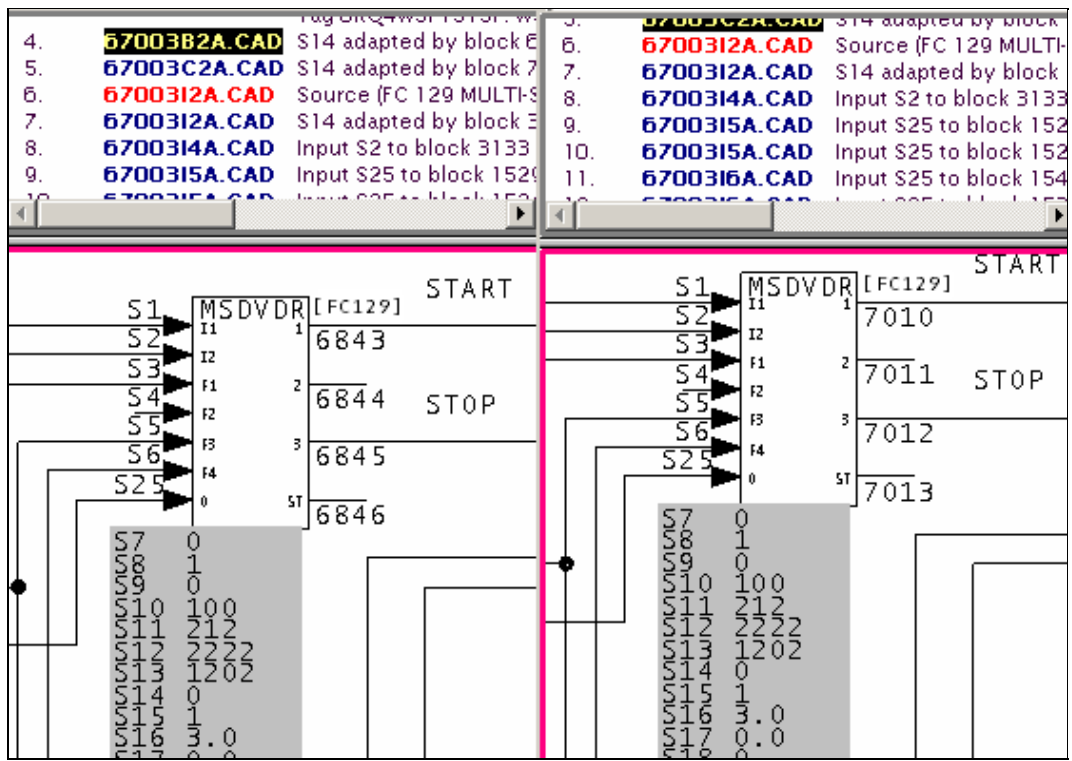
On sheets 67003B2A.CAD and 67003C2A.CAD, we will guess that there are MSDD blocks that do not have S14 adapted by an adapt block on that page. They have been orphaned.

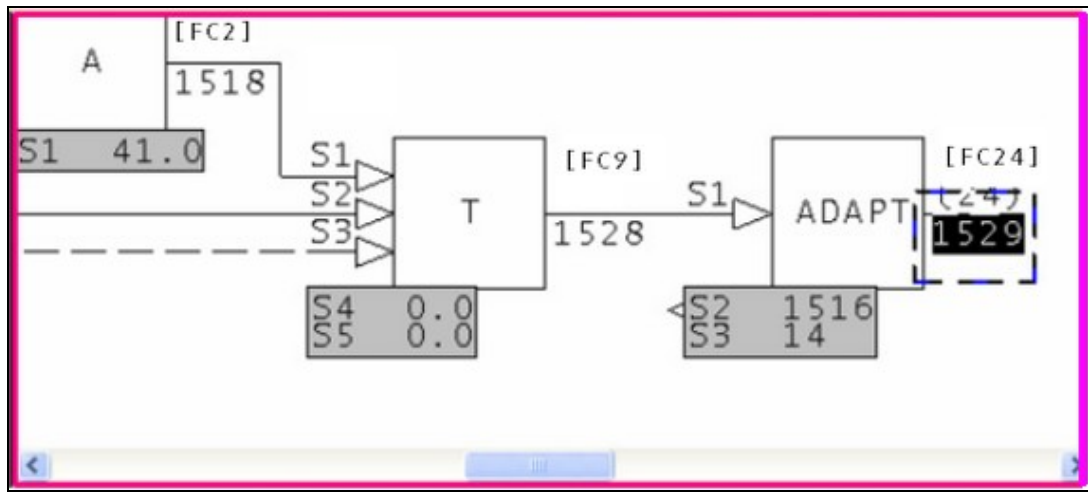
Adapt block Module 4,50,02 Block 1529 on drawing 45002P3:
Spec 14 on block 1516 out of range, (function code 40).

Click on the link in the error browser to bring up the CLD/CAD sheet where we have an adapt block issue.

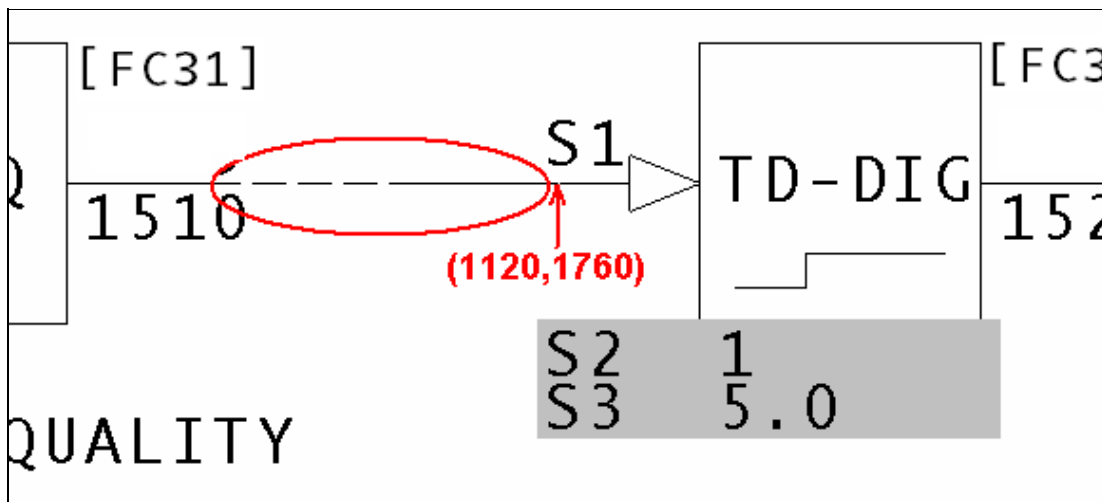
This message appears when DBDOC could not figure out the wiring and did not connect blocks to inputs where they are used. In the case below, we can guess that the line circled is really two separate line segments (quite possibly both digital dashed ones) and we could not figure out what to do, though it may be obvious to someone when he actually looks at it, of course.

```
Ambiguous wiring at 1120,1760: multiple wires at sink  
Ambiguous wiring at 4400,5140: multiple wires at sink Module 1,15,03 Block 23776 FC 38 S3  
Ambiguous wiring at 6110,4430: multiple wires at sink Module 7,101,04 Block 25785 FC 38 input 2 (old
```

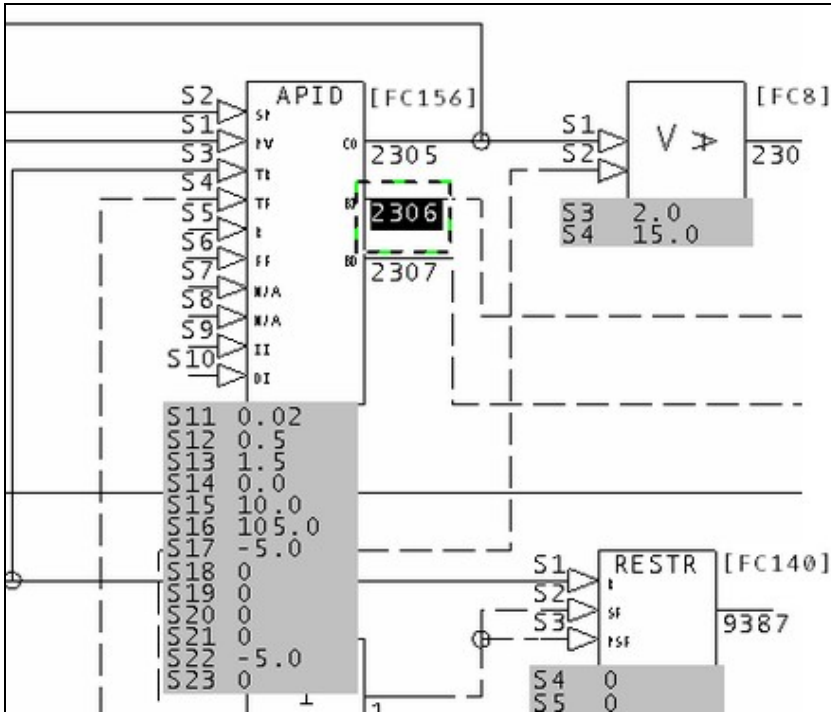
In this example, the Block Increase/Decrease Flag Outputs are in use. The documentation indicates that you should not use the output block increase or decrease flag if the quick saturation recovery option (S19 = 0) is being used.

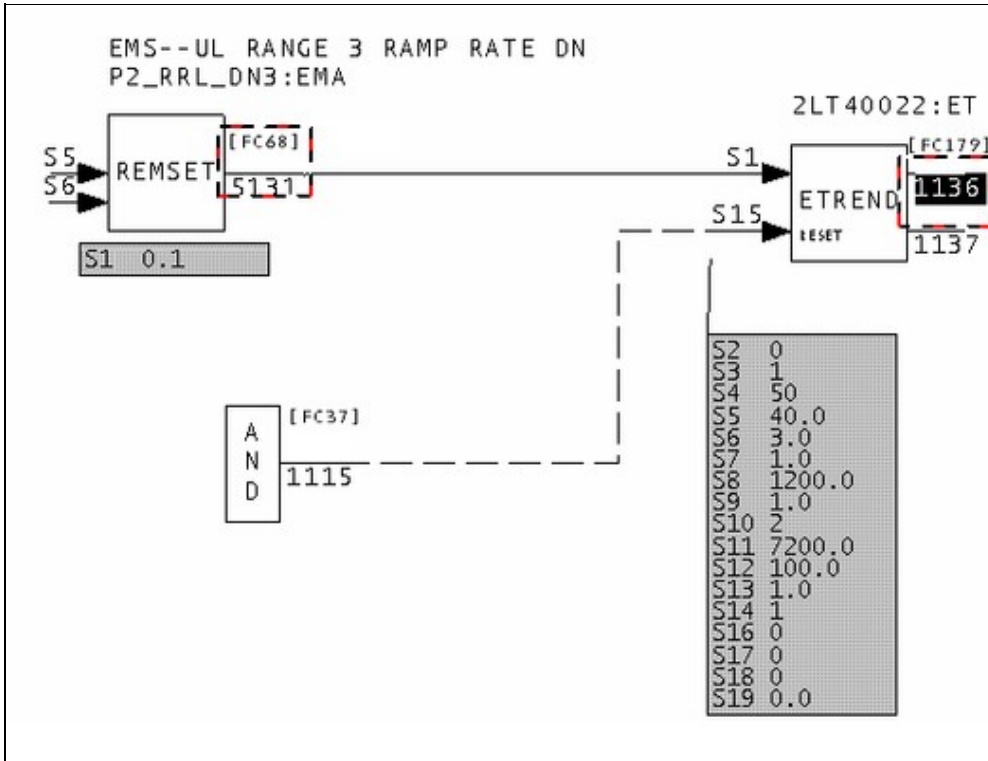
Enhanced Trend: Module 1,01,02 Block 1136 S1 is wired from FC 68 Module 1,01,02 Block 5131 but S2 0 specifies FC 30

The block addressed in S1 must match the input block type in S2 or a configuration error will result.

In this case, S1 is coming from the wrong type of block or S2 should be 3.

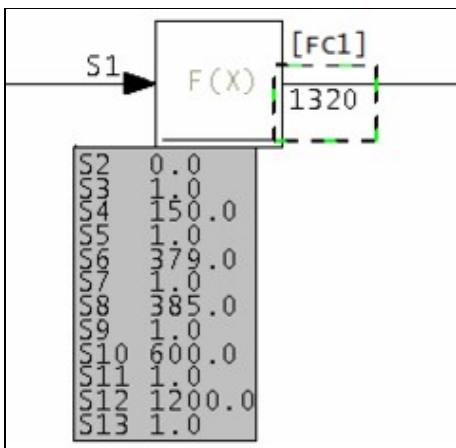
```
--Post Processing drawing 11002B9A.CAD
F(x) Module 1,01,02 Block 1320 graph is flat - value 1.00.
```

Notice that the Y value is 1.0 for all values of the input X value – that is, a constant.

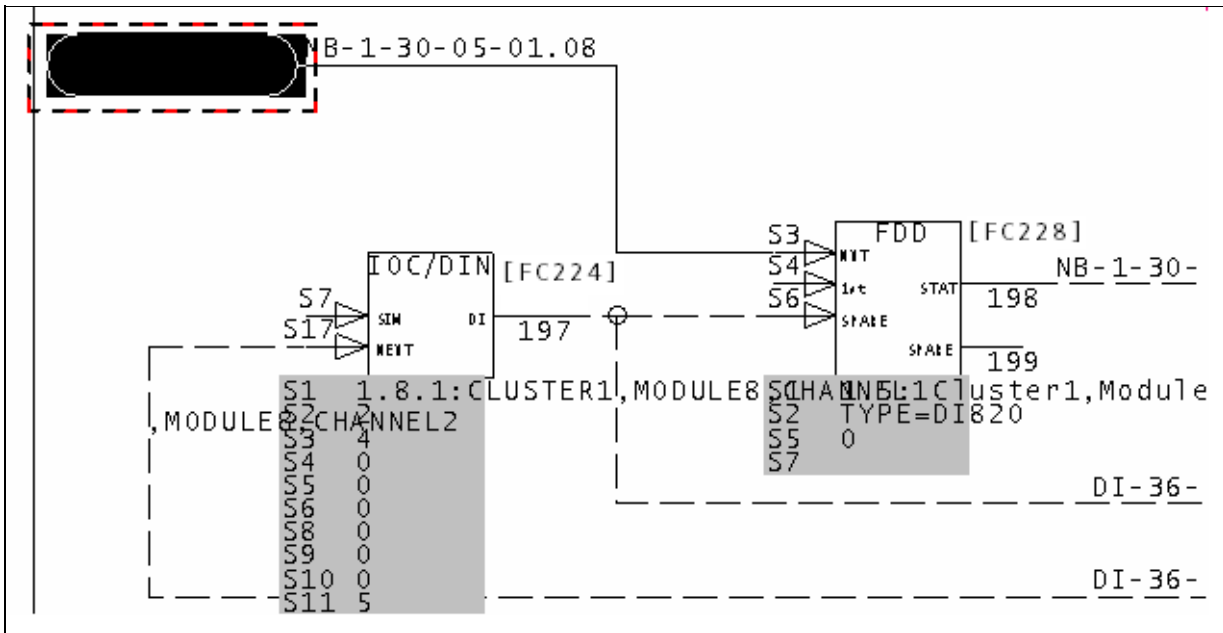
This undocumented issue was found by Ready Engineering when they inadvertently configured some Harmony I/O with empty input references.

Module 1,30,05 Block 198 FC 228 S3 wired from IREF (NB-1-30-05-01.08)with no source: module will compile but not run.

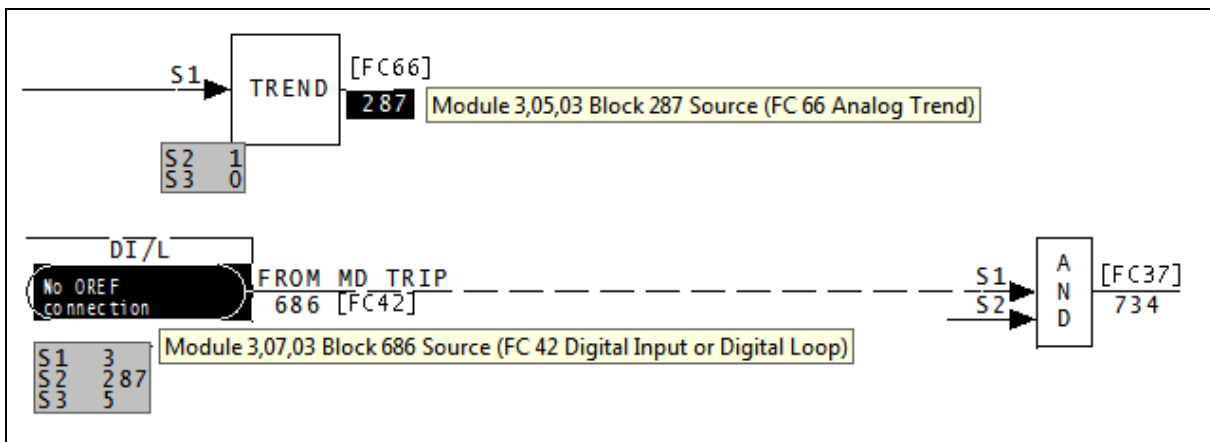
This message says that we found a block that is being imported illegally. Source and import block types do not match. These imports might not work. They often show a configuration error.

Data type mismatch: DI/L Reference on drawing 3070341 attempts to import analog value from Module 3,05,03 Block 287

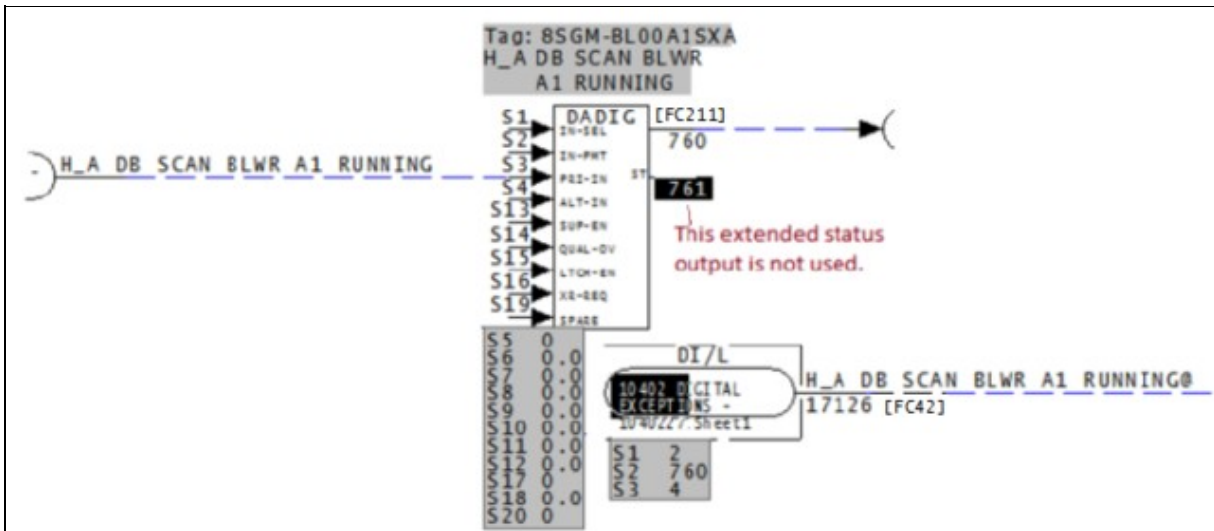
```
Extended status not imported: DI/L Reference on drawing 10104 BUS/LOOP INPUTS - LOOP DIGITAL02
imports DADIG from Module 1,04,02 Block 760
```

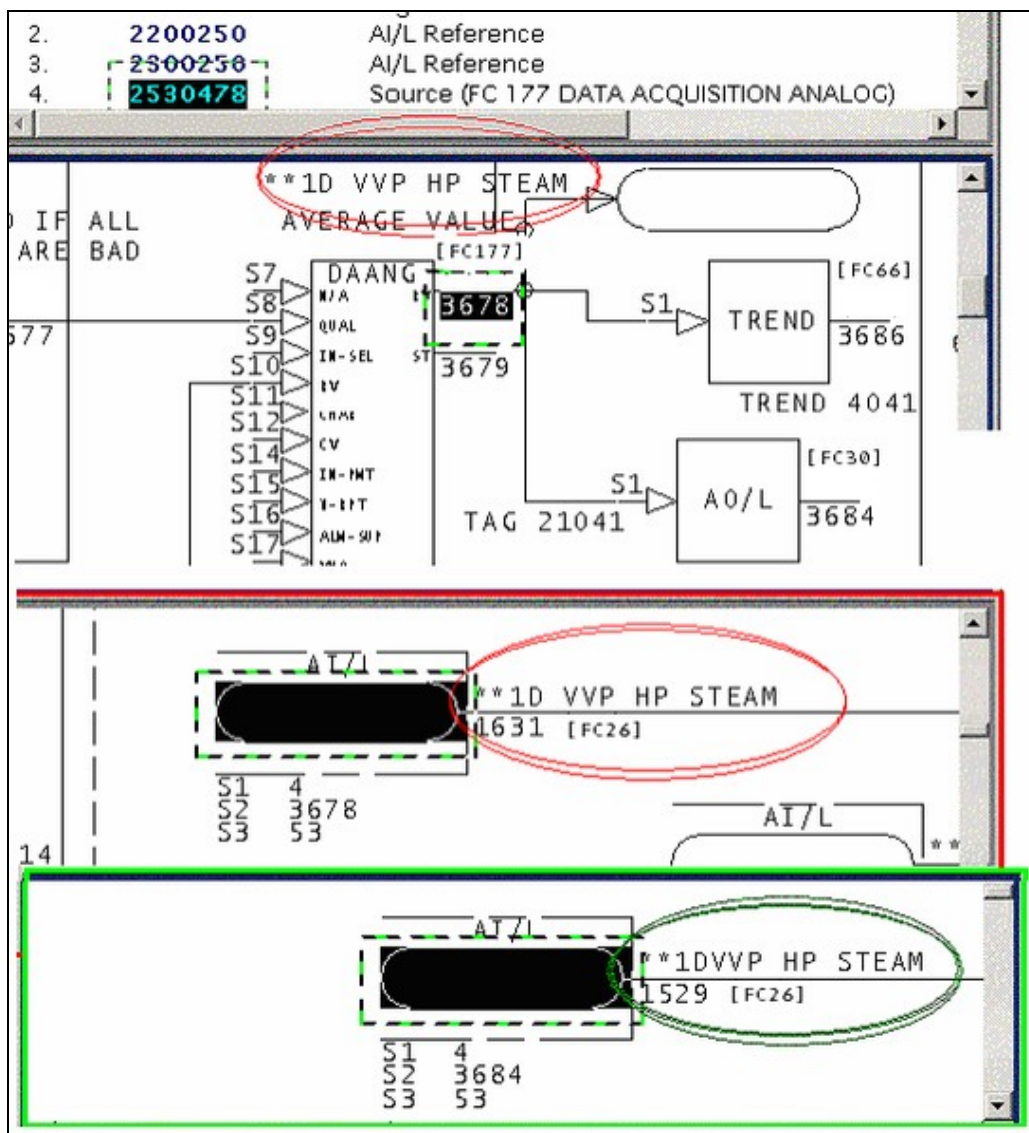
```
Parsing file H:\CLIENT~1\BAR\ACTIVE~1\EBY3FF5.CLD...  
IREF **1D VVP HP STEAM makes Module 2,20,02 Block 1631 FC 26 import Module 2,53,04 Block 3678  
instead of Module 2,53,04 Block 3684.
```

This Composer diagnostic tells you that the input reference on an import block overrides the specifications in the block that used to be there. As shown here, it can indicate an error. The output reference is wrong.

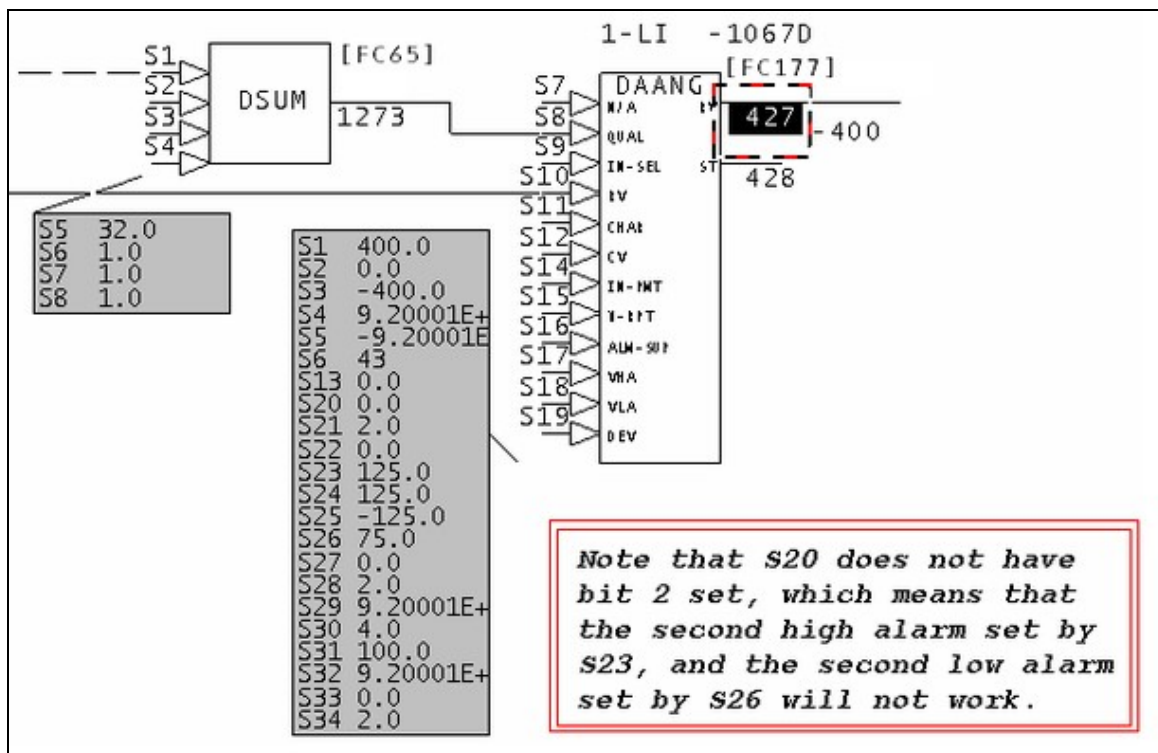
Multilevel alarms configured but disabled for Module 11,01,04 Block 427 FC 177.

We infer that the second and/or third alarm limits are intended to be used by comparing them (if not zero) to the span of the block. If they are less than or equal to the span, we assume that the the extra alarm status checking might be desired.

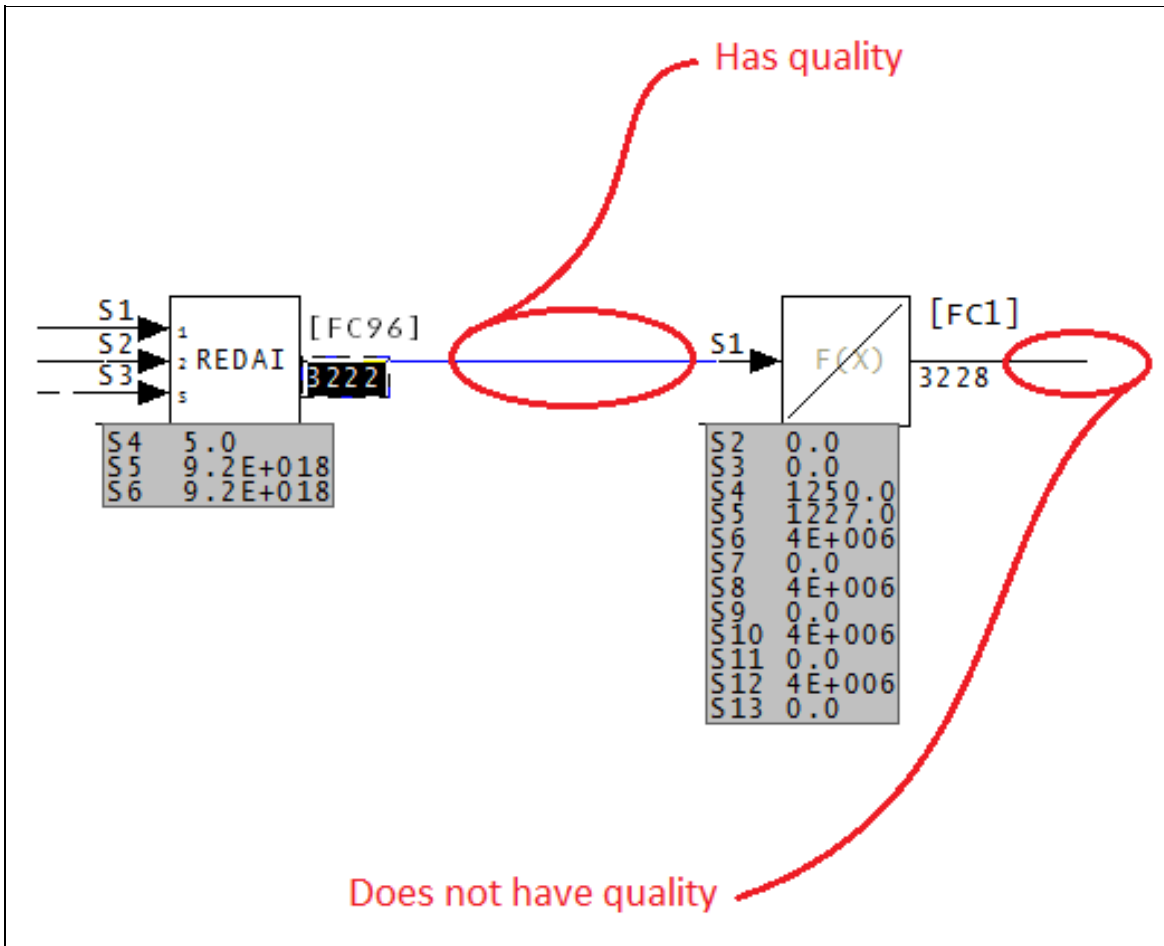
DBDOC does not necessarily track the quality all the way to its use, so it is possible that the block is eventually wired into a test quality block. This can be checked relatively easily by following the path to the places the quality is eventually lost. If a test quality block is found somewhere along the path, then this error is false, and we would recommend hiding it in the error browser.

On the other hand, it is possible that the quality is lost. This can lead to very wrong data being used in your system, so it is definitely worth looking into.

In this case, the REDAI block gives quality to the output value, and as it is entered into the F(X) block, it loses that quality.

This causes the values to be very wrong.

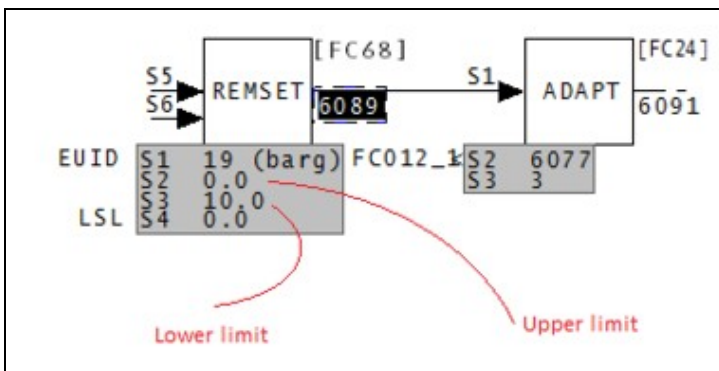
In the image below, the S3 value greater than an S2 value. Because of this, the range of acceptable values does not exist.

This block allows an operator to enter a constant to the control scheme. S2 and S3 are the limits of the range of values the operator can enter.

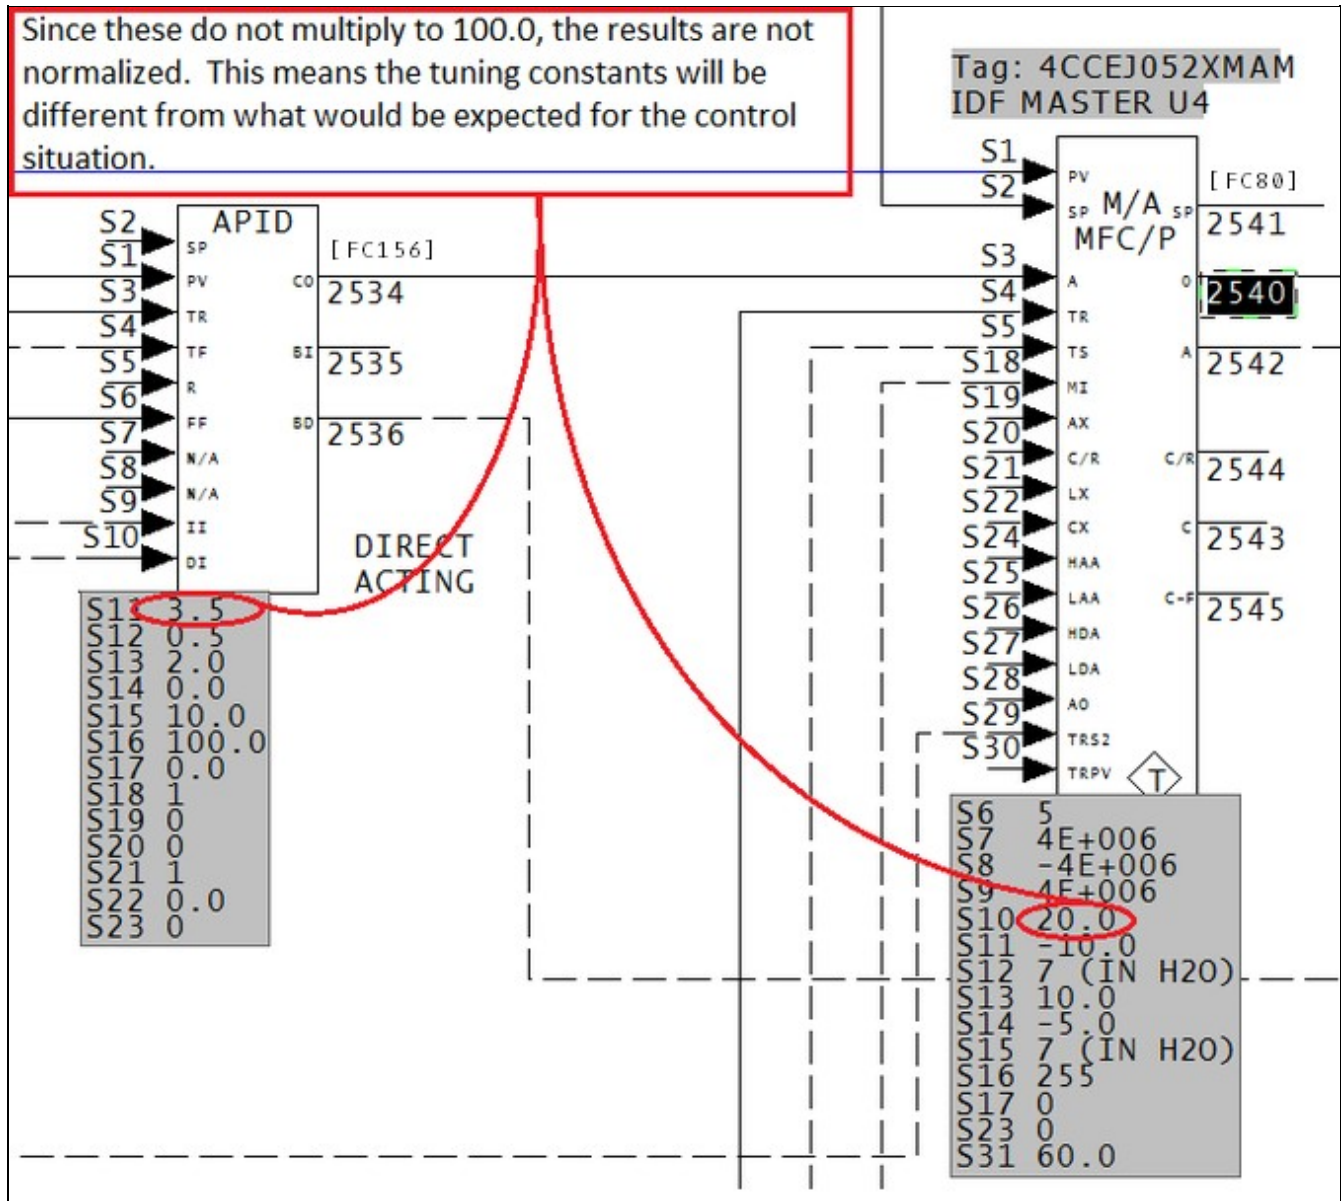
These messages show where that situation does not exist. These blocks can be tuned, but the tuning constants will not be "normalized" and thus will be subject to misinterpretation.

The product of S11 on the APID and the S10 on the M/A MFC/P must fall in the range of 80 to 125. This error occurs when the product is below that range.

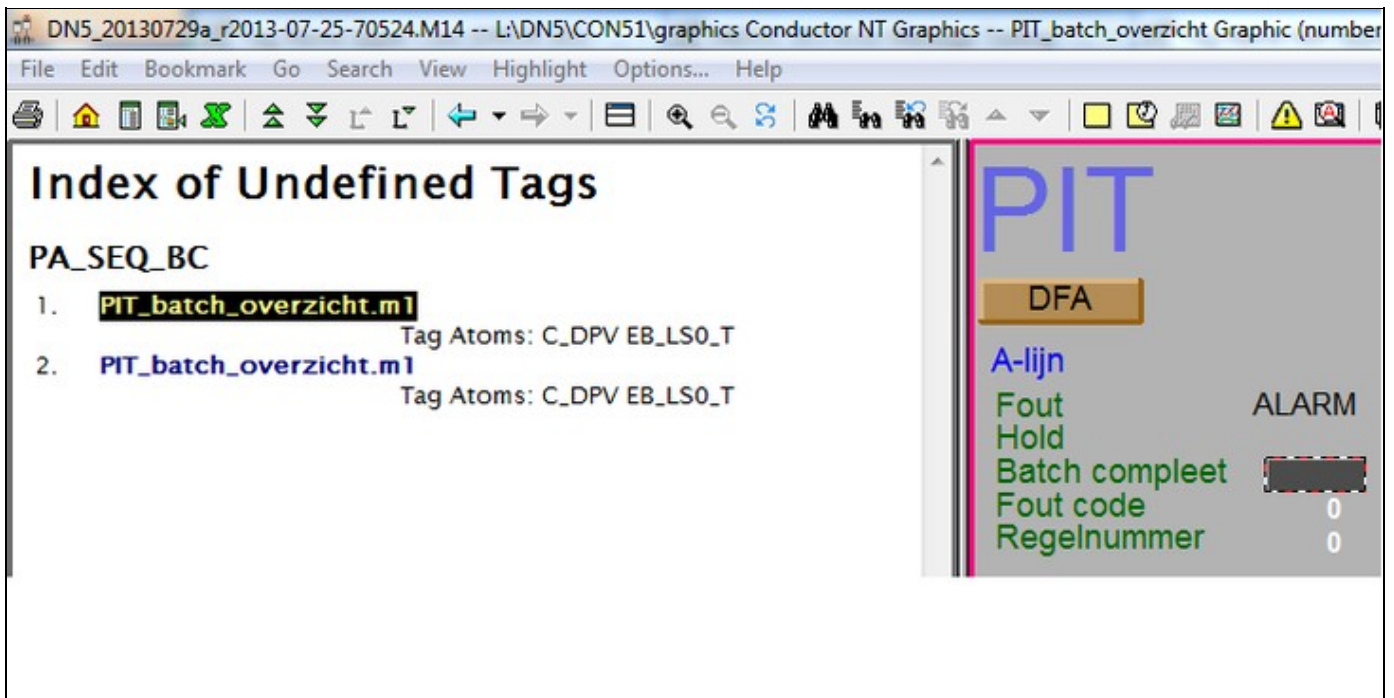
```
Tag atom UndefTag should be upper case
```

The INFI 90 graphics packages are based on Microsoft Access techniques using tagnames as keys, which must be all in uppercase. When they are not all upper case, DBDOC treats them as undefined, and places them in the Index of Undefined Tags. They may not work as expected.

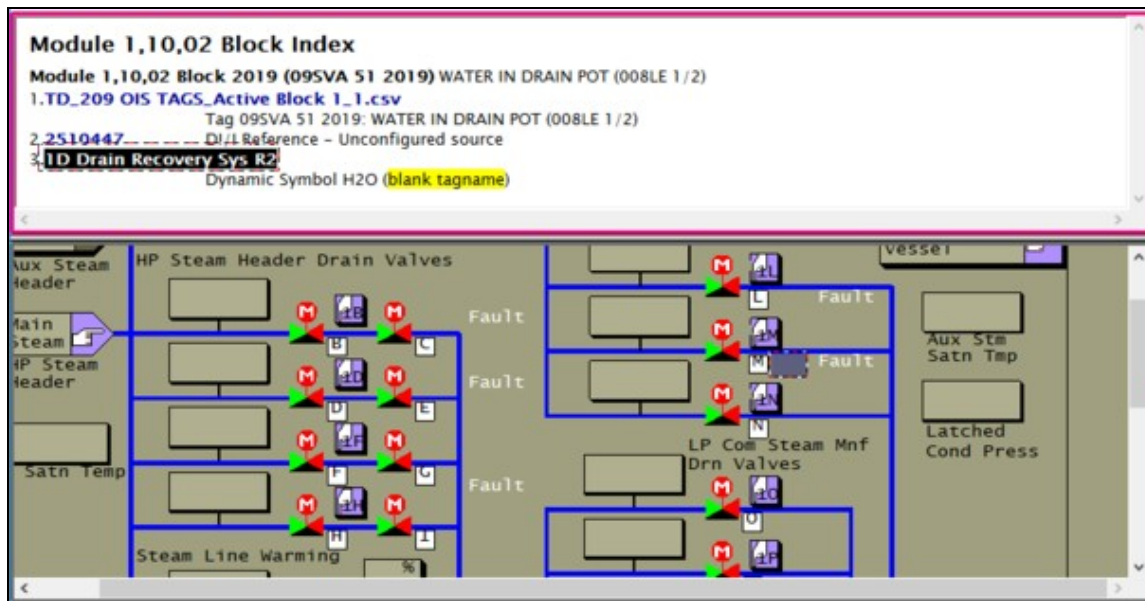
Finding tags with blank tagname

In a SODG graphics system, search for the text "blank tagname" (without the quotes). If you find any, you know that your system has graphics links being made by tag index instead of tag name. This is not stable in the long term.

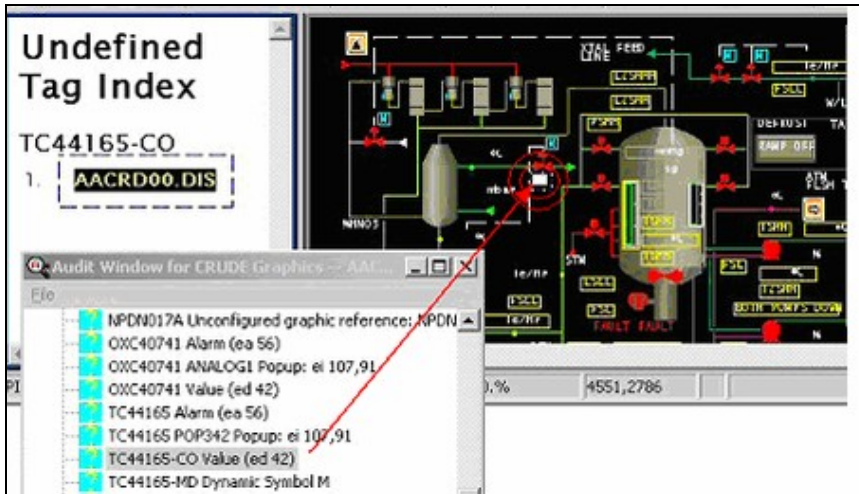
When many tags are not found on a single graphic, it means that graphic is very much broken, and is probably not in use.

See how the Audit Window actually shows you the type of data being displayed for the undefined tag.

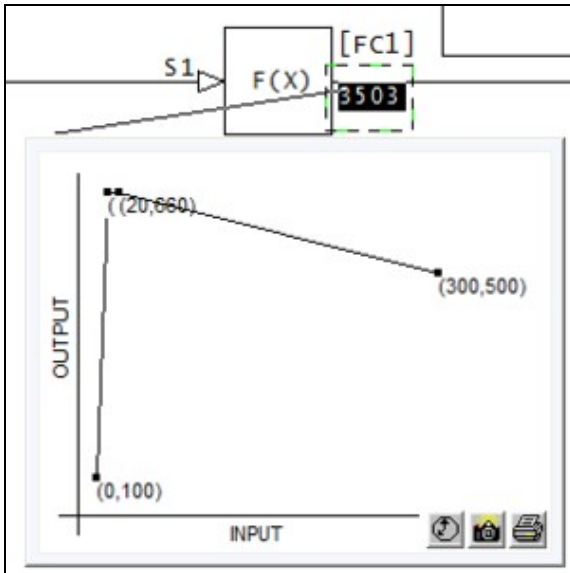
The F(x) looks like this:

(S10, S11)	40.0	200.0
(S12, S13)	50.0	100.0
